**ASSESSMENT OF STRUCTURAL ENCROACHMENT WITHIN THE STATUTORY RIGHT-OF-WAY OF 33KV POWER DISTRIBUTION LINES IN DAMATURU METROPOLIS, YOBE STATE, NIGERIA**

**Salisu Muhammad Baba<sup>1</sup>, Shu'aibu Aminu Belel<sup>2</sup>, Buhari Mohammed Ardo<sup>3</sup>**

**<sup>1</sup>Department of Urban and Regional Planning, Federal Polytechnic Damaturu**

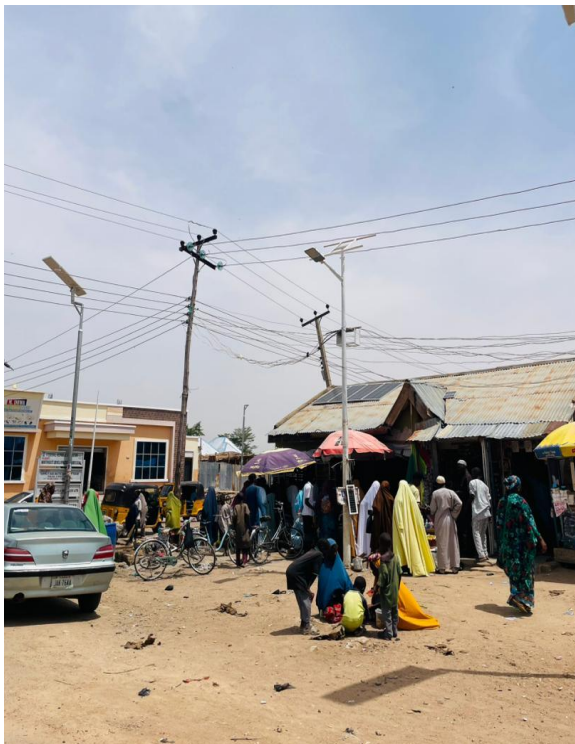
**Figure 2:** Shops directly under 33kV line at Bayan Tasha; **Source:** Field survey, 2026

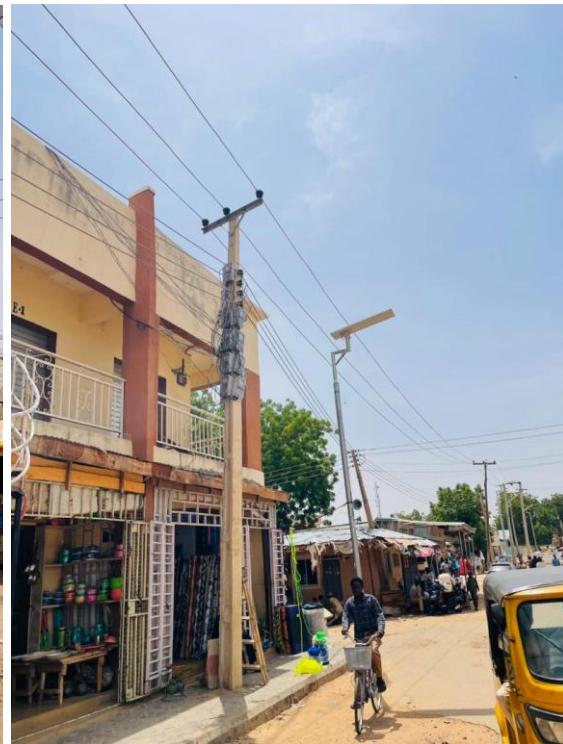
**Figure 3:** Encroached structure at central area

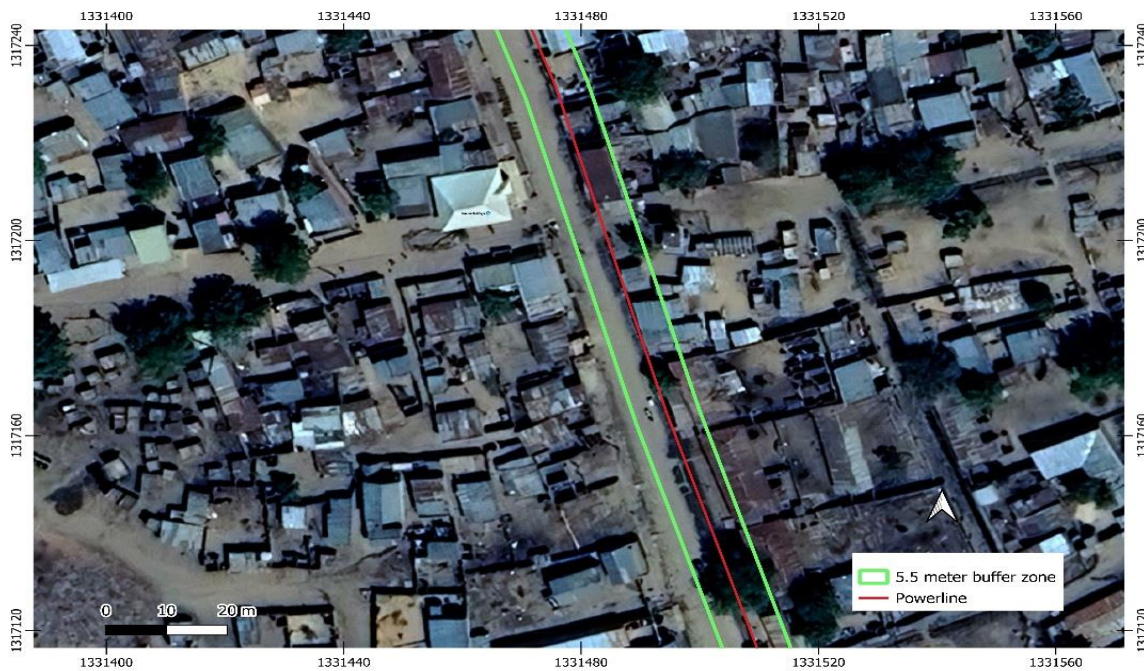
**Figure 4:** Encroached Structures Within the 5.5 m Buffer Zone of the 33 kV Powerline at Bayan Tasha

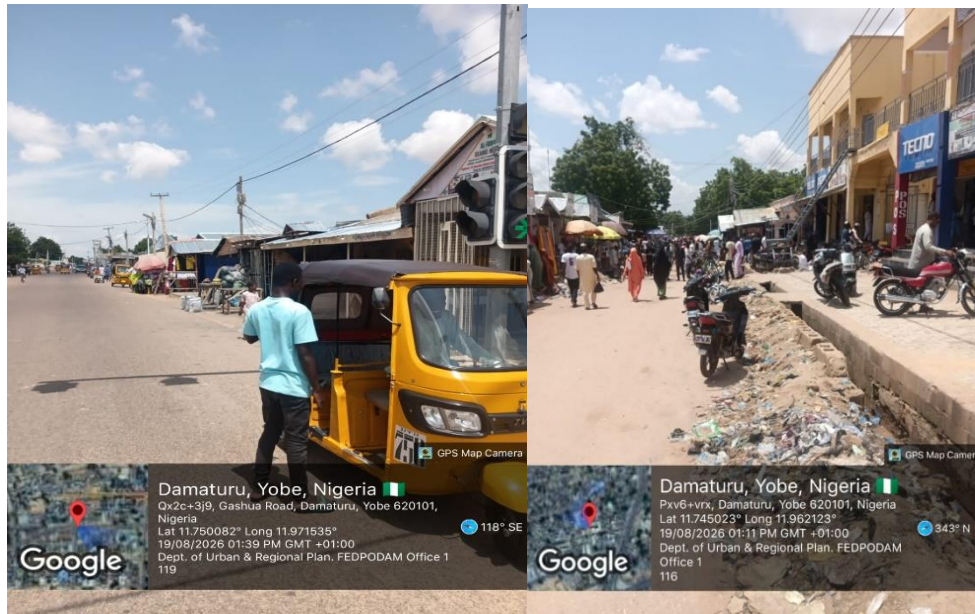
**Figure 4:** Encroached Structures; **Source:** Field survey, 2026
